**Namibian Civil  
Aviation Authority**

Safety Promotion  
and Quality  
Department

# Safety MATTERS

Providing the Namibian aviation industry and users with vital information on the latest aviation safety statistics and reports for the continuous improvement of safety systems:

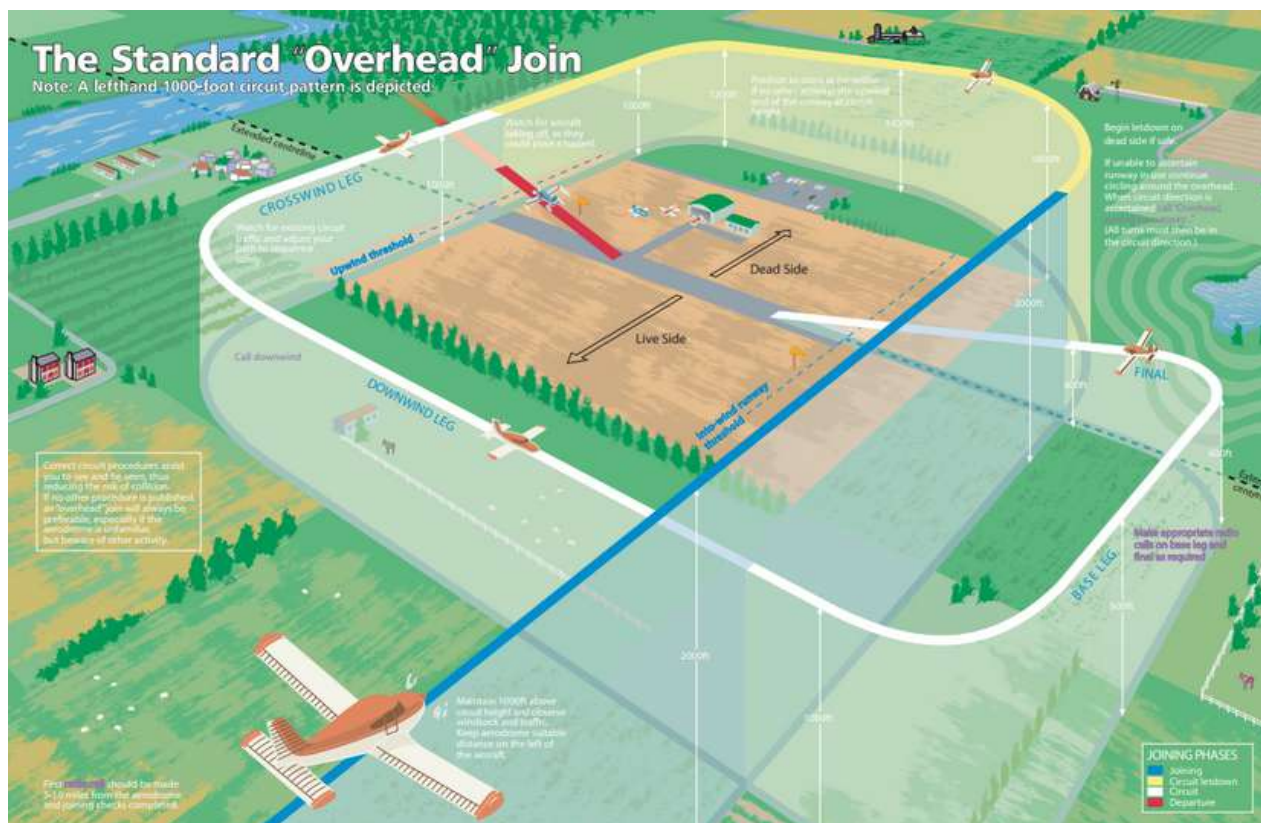
The radio communications procedure in VFR, whereupon no contact is available, should terminate in the "standard overhead join", along with light signals from the tower if there is one. So it is important to know both of these procedures.

Critical in this procedure is to remember to join overhead at 1000ft above the circuit, and all turns in the circuit direction, or to the left until a circuit direction can be confirmed. Thereafter descend on the "dead side" to arrive at circuit altitude abeam the upwind threshold to join downwind. This procedure is also used at unmanned airfields and should be known well.

The picture above is courtesy of the UKCAA  
and can be found online here:  
[StandardOverheadJoin \(caa.co.uk\)](http://StandardOverheadJoin(caa.co.uk))

More details about RCF are found in AIP  
ENR 1.6 paragraph 3.3 and ENR 1.5  
Paragraph 6
