# CFIT(Controlled Flight Into Terrain)

NCAA- FLIGHT  
OPERATIONS  
PRESENTATION  
BY: CAPT.  
VICKI  
MOMBOLA

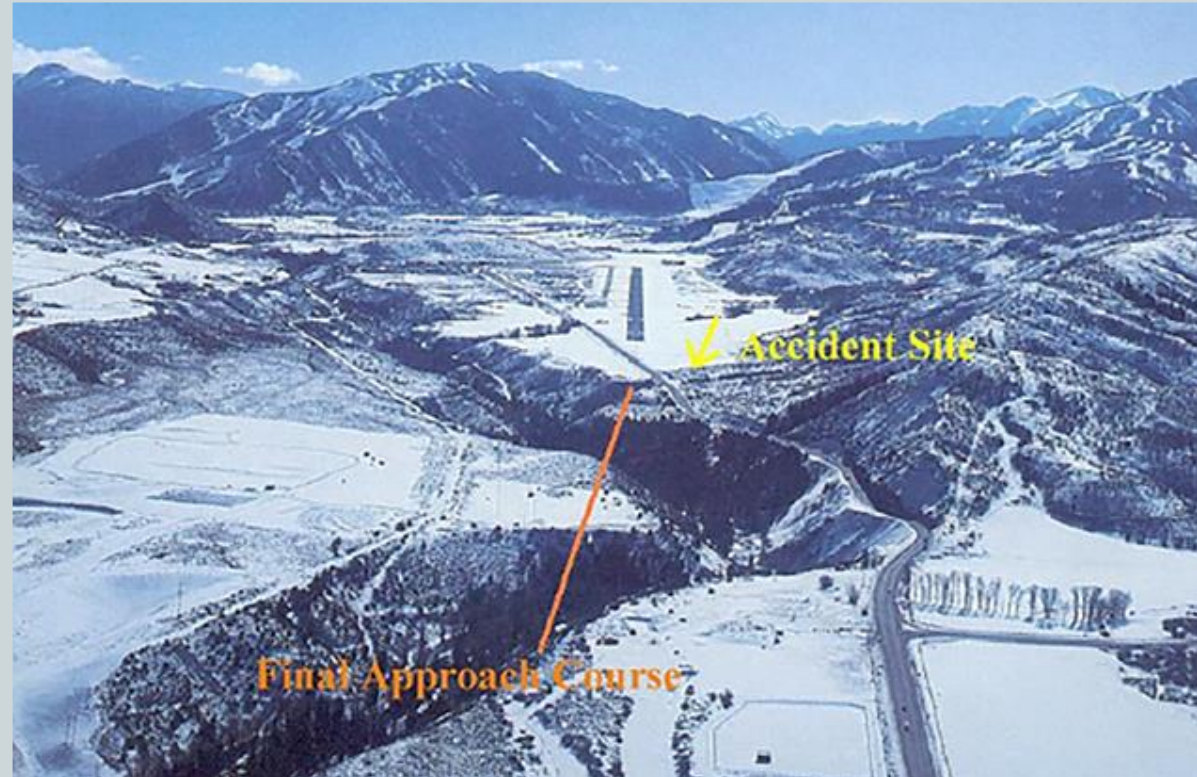
Figure: Airborne view of Aspen Runway 15, from [NTSB Accident Brief](#), Figure 2.

**The approach briefing sets the tone for the approach to come and should include terrain considerations. Many of us fail to give complete approach briefings when we expect visual conditions, "this will be a visual approach backed up by the ILS." In the case of the GIII that killed all on board on approach into Aspen in March of 2001, the captain never gave an approach briefing because he expected visual conditions. His poorly flown approach ended with the crew losing sight of the runway and killing all on board.**
